# International Journal of Architecture, Construction and Renovation (IJACR)

## Post-Fire Structural Condition Assessment and Remediation Strategy for a Seven-Storied Reinforced Concrete Industrial Building: A Case Study from the Ready-Made Garment Sector in Bangladesh

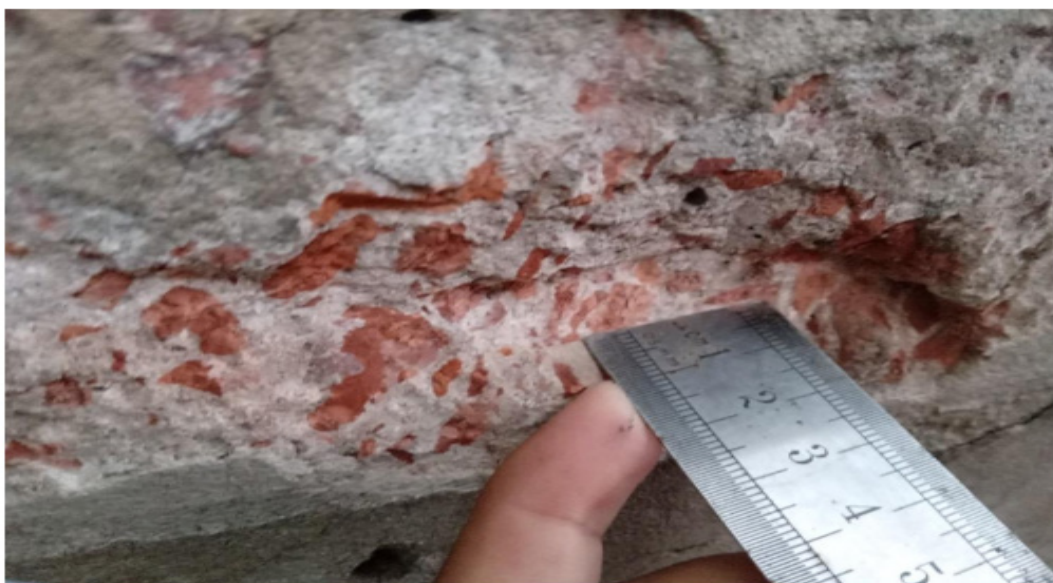
**Figure 1:** Physical measurement of fire-induced crack depth (approximately 8 mm) at a column face using a feeler/ruler technique.

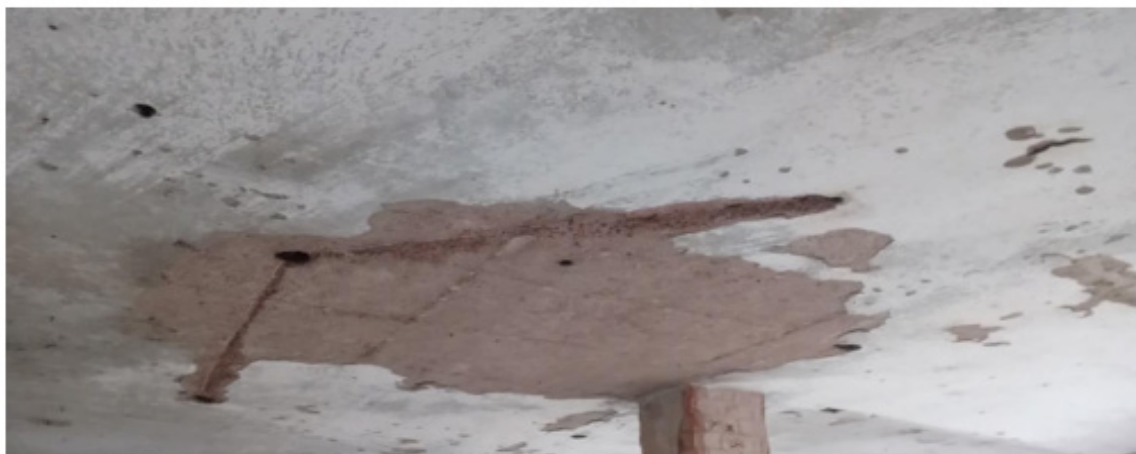
**Figure 3:** Spalling of soffit plaster on the third-floor flat-plate slab, typical of the surface-only distress observed across the slab away from the toilet zone.

fresh-water curing period. For the flat-plate slab, existing plaster and clear cover were removed, 10 mm diameter shear connectors were epoxy-doweled at 48-inch centres, an 18-gauge wire mesh (38 mm centre-to-centre) was fixed with nails at 24-inch centres, and the surface was reinstated with a 1/2-inch coarse-sand (1:3) plaster coat followed by a 1/4-inch fine-sand (1:4) finish coat. At the toilet-zone slab, where an additional masonry wall load is carried, a ferrocement overlay (1.5-inch mortar with wire mesh, cement:sand = 1:3) bonded with an epoxy coating and mechanically anchored through drilled slab holes was proposed in place of the standard wire-mesh plaster detail, to provide additional reserve capacity.

| Member type | Grid locations (representative) | Count | Governing finding | Remediation approach |
|---|---|---|---|---|
| Flat-plate slab | H~A (typical) and toilet zone (C-9) | Full 3rd floor | Max. carbonation 23.6 mm; core concrete unimpaired by fire | Reinstate clear cover with 18-gauge wire mesh plaster; ferrocement overlay with shear connectors at toilet zone |
