# International Journal of Architecture, Construction and Renovation (IJACR)

## Post-Fire Structural Condition Assessment and Remediation Strategy for a Seven-Storied Reinforced Concrete Industrial Building: A Case Study from the Ready-Made Garment Sector in Bangladesh

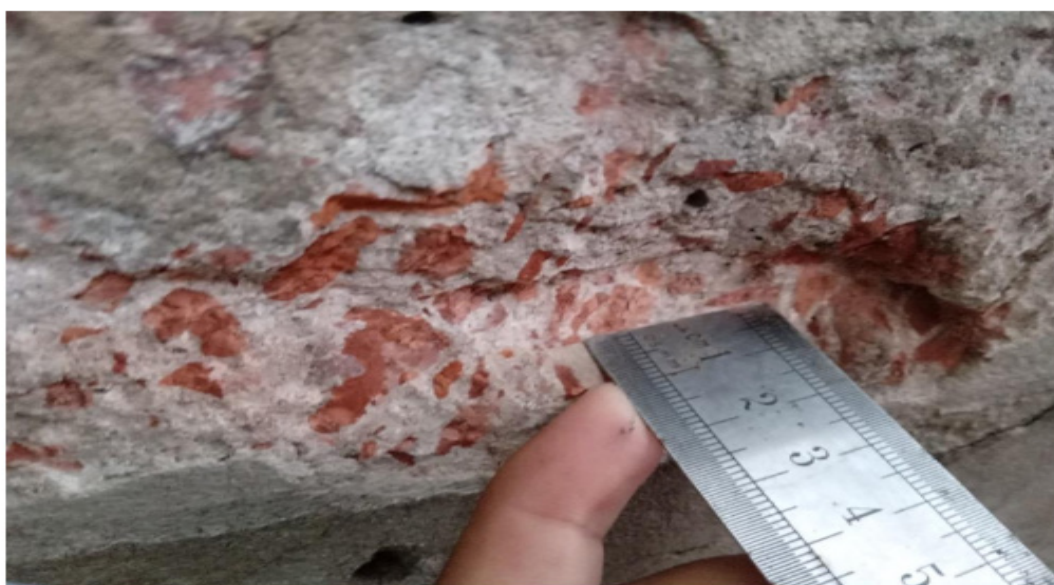
Physical crack measurement combined with UPV testing was carried out at eighteen columns (Cr-01 to Cr-18) and two beam spans (FB-01, FB-02). Crack depths measured directly ranged from approximately 8 mm to 200 mm, while UPV-based estimates at four columns where both methods were applied (grids E-6, E-4, D-4 and C-6) ranged from 155.2 mm to 213.7 mm and were found to closely corroborate the physically measured values, in three of four cases exceeding the tape-measured depth by only 1 to 15 percent, confirming that the visible crack length on the concrete surface generally under-represented the true depth of fire-induced internal cracking. Where UPV

**Figure 1:** Physical measurement of fire-induced crack depth (approximately 8 mm) at a column face using a feeler/ruler technique.

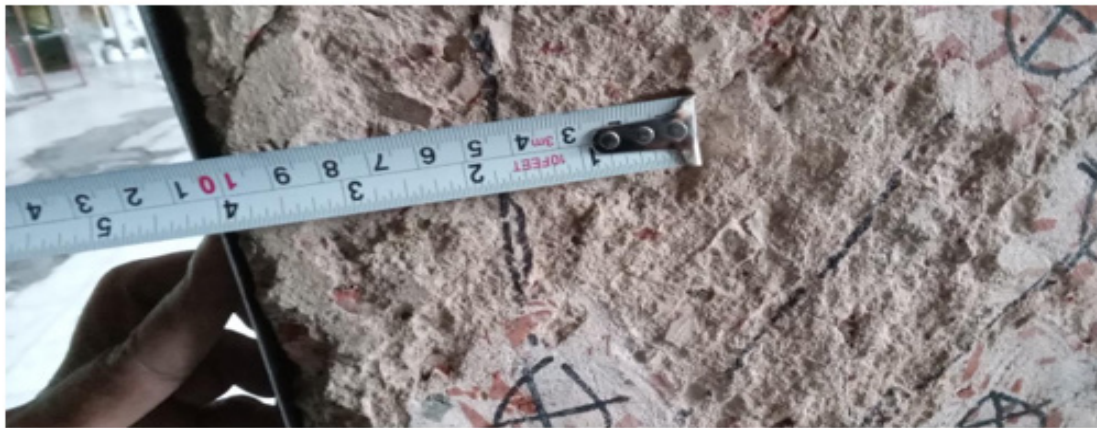
results were available, the larger of the two values was conservatively adopted for damage classification. The most severely affected locations were columns at grids D-4 (UPV-measured depth 213.7 mm, carbonation depth 48.1 mm) and E-6 (measured depth 202 mm), both of which exhibited cracking that clearly penetrated beyond the nominal 1.5-inch reinforcement clear cover. Both beam spans FB-01 and FB-02, located along grid line B between grids 3 and 9, exhibited full-depth mid-span cracking with a carbonation depth of 25.2 mm and were consequently excluded from the retained structural model pending repair.

**Figure 2:** Tape measurement of a fire-induced column crack (approximately 105 mm) prior to correlation with the corresponding UPV-estimated crack depth

| Member type | Grid locations (representative) | Count | Governing finding | Remediation approach |
|---|---|---|---|---|
| Column - core damaged | G/4, F/1, F/4, F/6, F/9, E/4, E/6, E/9, D/4, D/6, D/9, C/6, C/9, B/3, B/5, B/6, B/7, B/9 | 18 | Max. carbonation 48.1 mm; max. UPV crack depth 213.7 mm, exceeding clear cover | Remove damaged concrete, epoxy-inject crack, new rebar core, jacket with non-shrink micro-concrete, epoxy bonding coat |

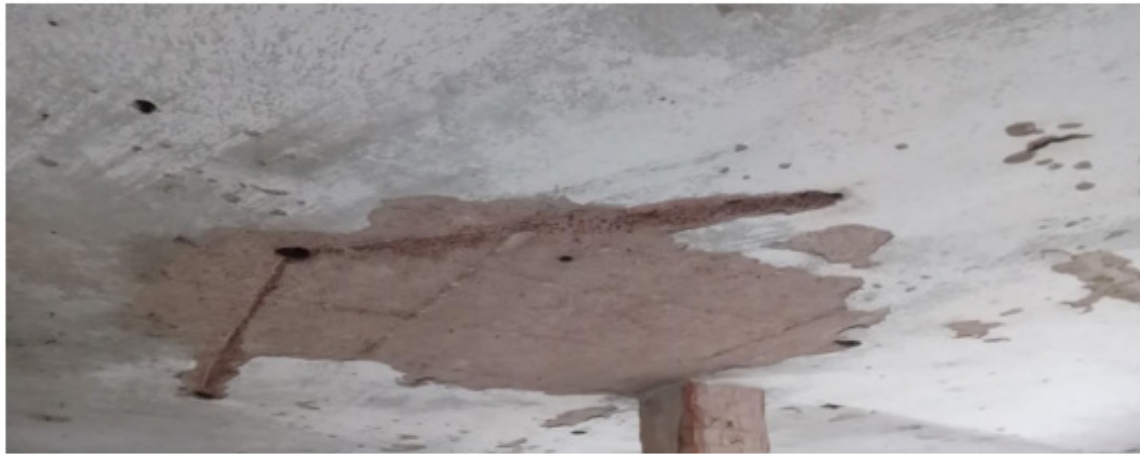
**Figure 3:** Spalling of soffit plaster on the third-floor flat-plate slab, typical of the surface-only distress observed across the slab away from the toilet zone.

fresh-water curing period. For the flat-plate slab, existing plaster and clear cover were removed, 10 mm diameter shear connectors were epoxy-doweled at 48-inch centres, an 18-gauge wire mesh (38 mm centre-to-centre) was fixed with nails at 24-inch centres, and the surface was reinstated with a 1/2-inch coarse-sand (1:3) plaster coat followed by a 1/4-inch fine-sand (1:4) finish coat. At the toilet-zone slab, where an additional masonry wall load is carried, a ferrocement overlay (1.5-inch mortar with wire mesh, cement:sand = 1:3) bonded with an epoxy coating and mechanically anchored through drilled slab holes was proposed in place of the standard wire-mesh plaster detail, to provide additional reserve capacity.

| Member type | Grid locations (representative) | Count | Governing finding | Remediation approach |
|---|---|---|---|---|
| Flat-plate slab | H~A (typical) and toilet zone (C-9) | Full 3rd floor | Max. carbonation 23.6 mm; core concrete unimpaired by fire | Reinstate clear cover with 18-gauge wire mesh plaster; ferrocement overlay with shear connectors at toilet zone |
