# International Journal of Architecture, Construction and Renovation (IJACR)

## Crack Investigation and Residual Strength Check of Beams in an Existing Six-Story Reinforced Concrete Industrial Building in Bangladesh

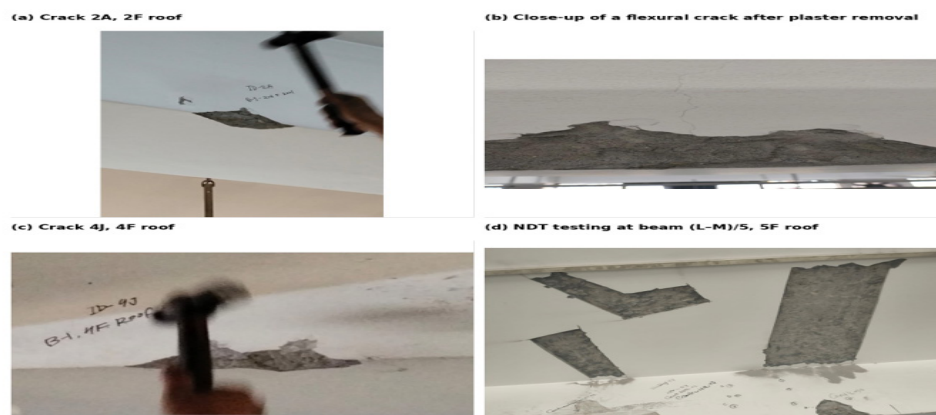
that the bare concrete, and the reinforcing bar underneath it where relevant, could be seen directly. Each crack was then placed into one of three simple categories: (i) crack goes past the main reinforcement bar, (ii) crack stays within the concrete cover only, or (iii) crack is only in the plaster finish, with no structural concrete involved.

**Figure 2:** Representative field photographs from the crack survey: (a) crack 2A on the 2nd floor roof; (b) close-up of a flexural crack after plaster removal; (c) crack 4J on the 4th floor roof; (d) NDT testing (UPV, carbonation, crack width) at beam (L–M)/5 on the 5th floor roof.

A different repair method is recommended for each crack type, following the general assessment-and-repair framework of ACI 562-19 (American Concrete Institute, 2019). For cracks that go past the main bar: remove the plaster and any loose or cracked concrete, clean any exposed rusted bar with a wire brush, apply an anti-corrosion coating if needed, add shear connectors across the repaired section, apply an epoxy bonding agent before recasting, patch with micro-concrete, cure for at least 14 days after removing the formwork, and finish with 12 mm plaster and paint. For cracks that stay within the cover only: a lighter repair using wire mesh (1 mm thick, 25–38 mm spacing) bonded with epoxy primer, then plastered and painted, is enough. Where carbonation has reached the bar, the damaged cover concrete should be cleared back at least 1 in. past the bar and an anti-carbonation coating applied before patching. Bonding-agent selection matters for how well the new and old concrete act together; comparative work on alternative binding and bonding systems for concrete repair supports the choice of a dedicated epoxy bonding agent over a plain cement slurry at the repair interface used here (Saad, 2025a). For future repair batches, partial replacement of cement with pozzolanic supplementary materials is also worth considering, since such substitutions have been shown to improve compressive strength and chloride resistance in comparable concrete mixes without major cost penalties (Aanu *et al.*, 2025). Until these repairs are finished, a temporary live-load limit of 2 kPa is recommended on the affected floors so that production can continue on a restricted basis.
